**ECAC Group of Experts
on Aviation Accident
Investigation (ACC)**

**Workshop on
Underwater Recovery Operations
Dubrovnik, 10-12 June 2009**

Report

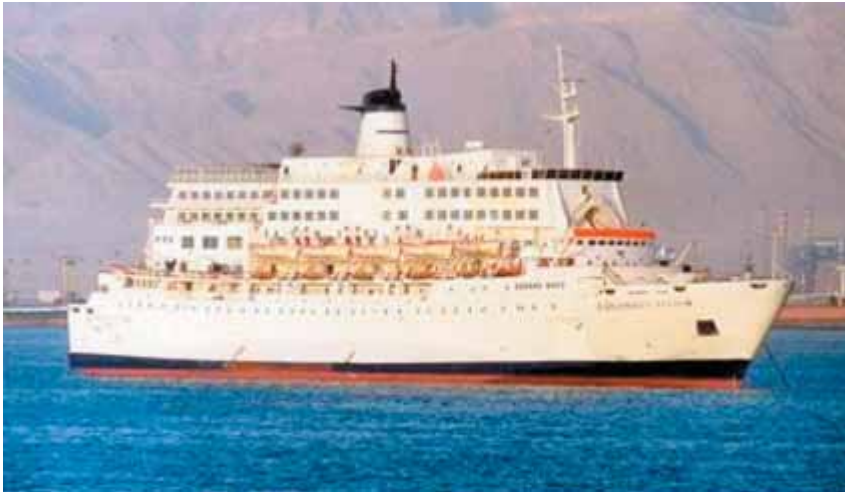
A search area was indentified that reflected estimates of the vessel's last known position from various sources, and where items from the ferry had been recovered. The

search area was split into a grid of eight parallel tracks one nautical mile apart and five nautical miles long, which would take about 10 hours to search. However, no signal was detected in this area, so a second search grid was formed alongside the first, along the route the ferry would have been taking. The signal was soon detected

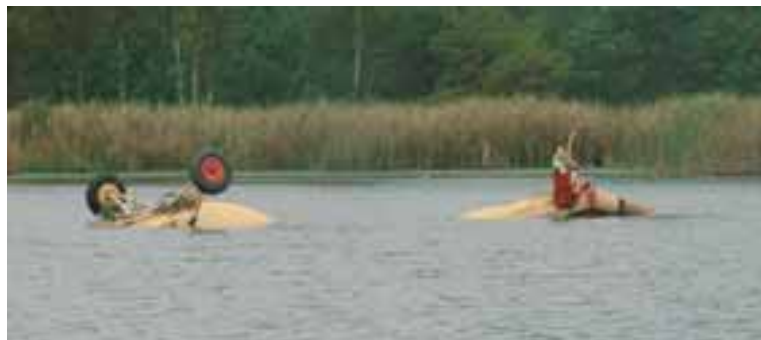
In July 2005 an Mi2 helicopter engaged in a firefighting operation near Police stalled and crashed into Lake Piaski, when the bucket it had lowered in order to take up water became overloaded with mud. There was immediately an ecological problem, as the helicopter (pictured opposite) contained some 400 litres of fuel. The wreckage had to be surrounded by special protective curtains during the operation to pump out the fuel. It could then be towed to the bank of the shallow lake, and recovered.

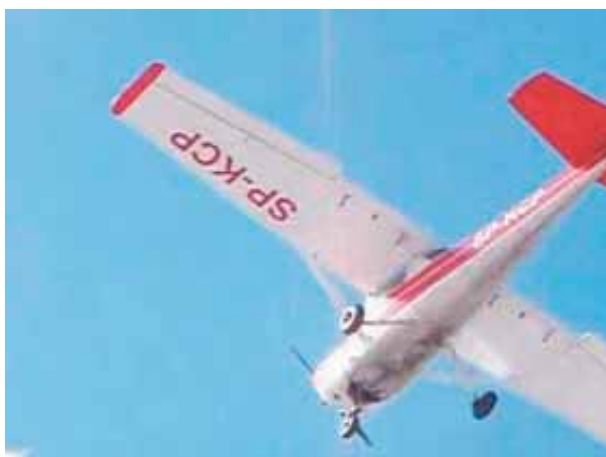
The next recovery attempt was made by four boats over a period of twelve hours, and used large sealed metal tubes (pictured below) which together had twice the displacement of the aircraft, inserted under its wings. Owing to the weight of sand which had by this time - some seven weeks after the accident - collected in the wreckage, which made it three times heavier than normal, this attempt, too, failed. However, a further attempt using the same metal containers succeeded, after sand had been sucked out of the wreckage. This operation took twenty hours, with four boats assisting, in seriously adverse weather conditions (rain, snow, air temperatures of 2-5 degrees C). The aircraft was then towed very slowly to the bank of the river, in an upside down position, before being hoisted out of the water.

Attempt to recover by using metal containers under wings between fuselage and struts failed due to heavy aircraft full of sand (3 times heavier) and the stream. Action was taken 12 hours with using 4 boats. Containers had 2 times bigger displacement than aircraft.

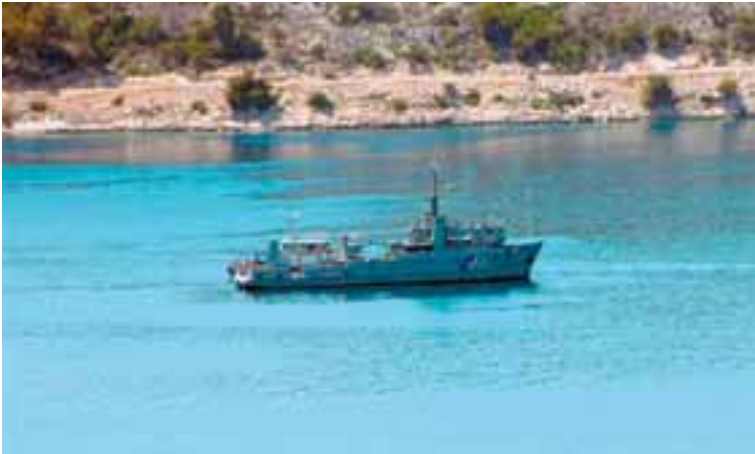
The second day of the workshop was devoted wholly to practical exercises conducted from aboard vessels very generously made available by the Croatian Navy, namely SB-51 FAUST VRANCIC (mine-hunter, pictured opposite), SB-73 KORKULA (salvage ship), and a number of fast inflatable craft.

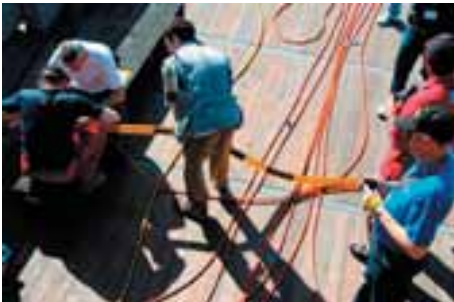
The first exercise saw the deployment from the FAUSTVRANCIC of the UK AAIB's towed hydrophone array (pictured opposite), to "box" the general location of the Flight Recorder. A search grid was drawn up on the basis of the eyewitness reporting, and the ship then followed this pattern, traveling at 5 knots and completing a series of parallel two-mile tracks, each with one mile of separation from

the next. During this period, workshop participants aboard the FAUST VRANCIC were able to handle and use in real conditions the hand-held hydrophones which would be deployed later in the exercise, and to view the signals from the towed array as shown on the laptop computer to which it was linked.

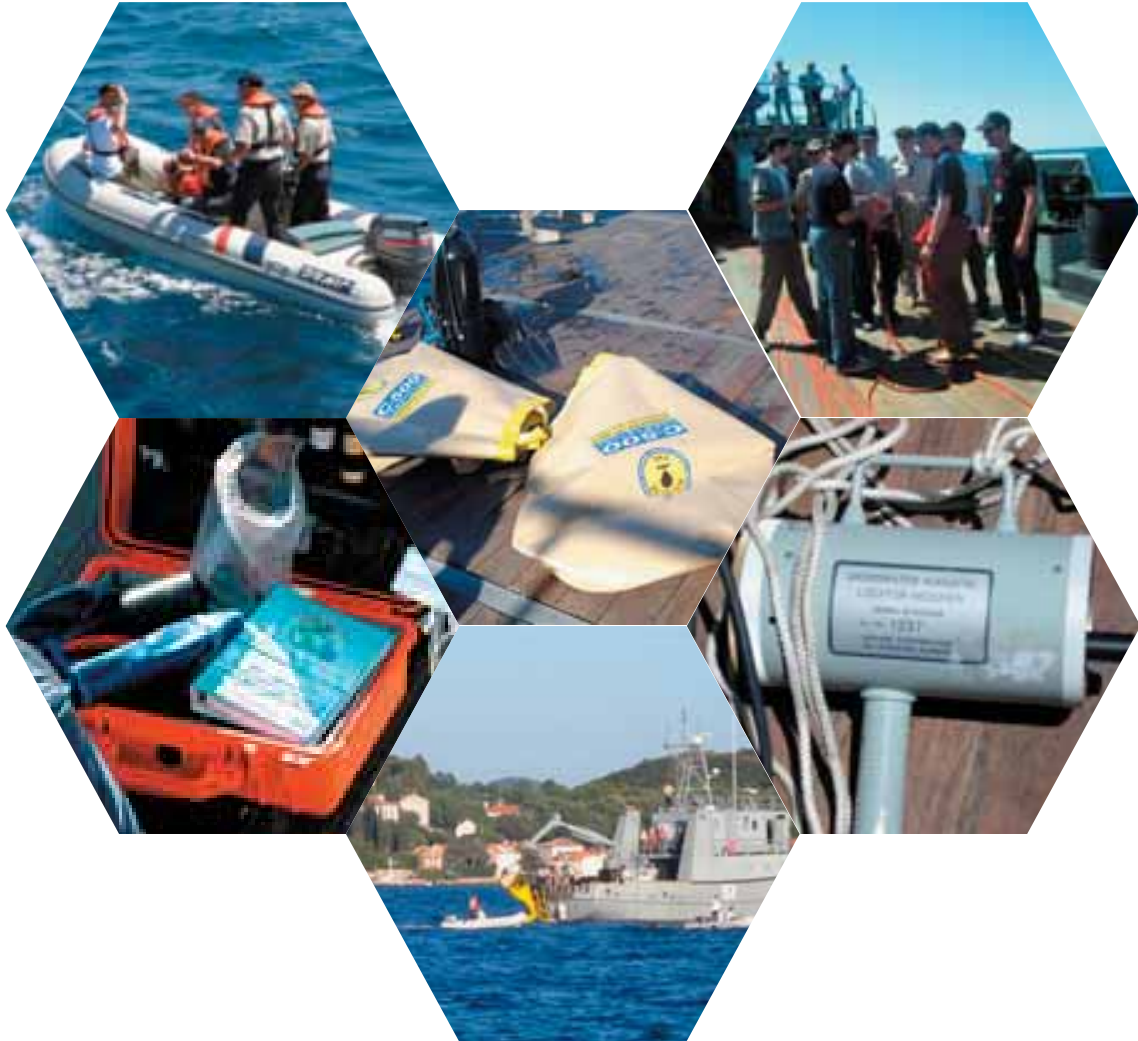
transferred. Divers provided by the Croatia and Hungarian authorities were then deployed from the FAUST VRANCIC aboard inflatable craft. Diving on the wreckage, they attached to it a number of “parachutes” (centre picture below), able to be inflated with compressed air carried in tanks taken down by the divers. Once inflated, these “parachutes” brought the aircraft wreckage to the surface, where it was made fast to the salvage crane fitted on the KORCULA.

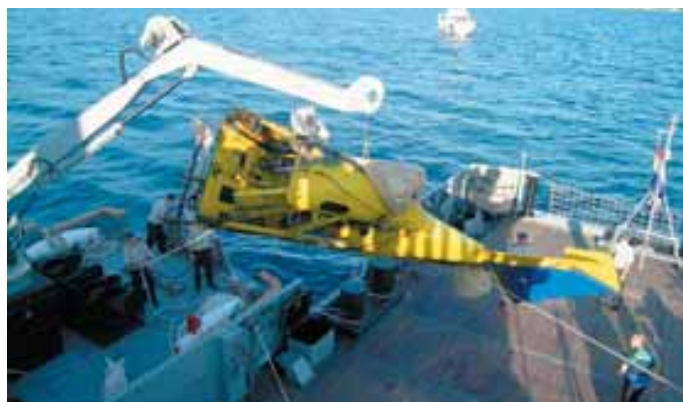
In the final exercise, the wreckage of the general aviation aircraft was carried by the KORKULA to the FAUST VRANCIC, and lifted aboard the latter’s aft deck space, care being taken to ensure that this operation inflicted no additional damage on the aircraft.

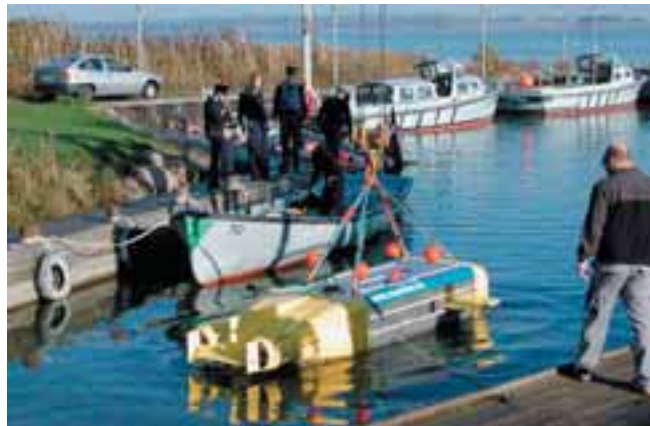
A surface search by helicopters, the dragging of the lake by two surface vessels, and a search using metal detectors mounted on inflatable craft failed to locate the wreckage. At this point, the Danish AIB were offered assistance by MARIDAN, a company which had developed a small robot submarine for use in gold mining operations in South Africa. This UAV, ‘MARTIN’, was equipped with side scan sonar, GPS and an inertial navigation system. Its preparation and launching had taken some six hours, after which it was controlled from a small surface vessel equipped as a control centre. It was directed to follow a defined search programme, on completion of which it surfaced and uploaded its findings to the control centre. In due course ‘MARTIN’ located the wreckage of the Robinson R44, which was subsequently recovered using a hoist erected between two small barges.

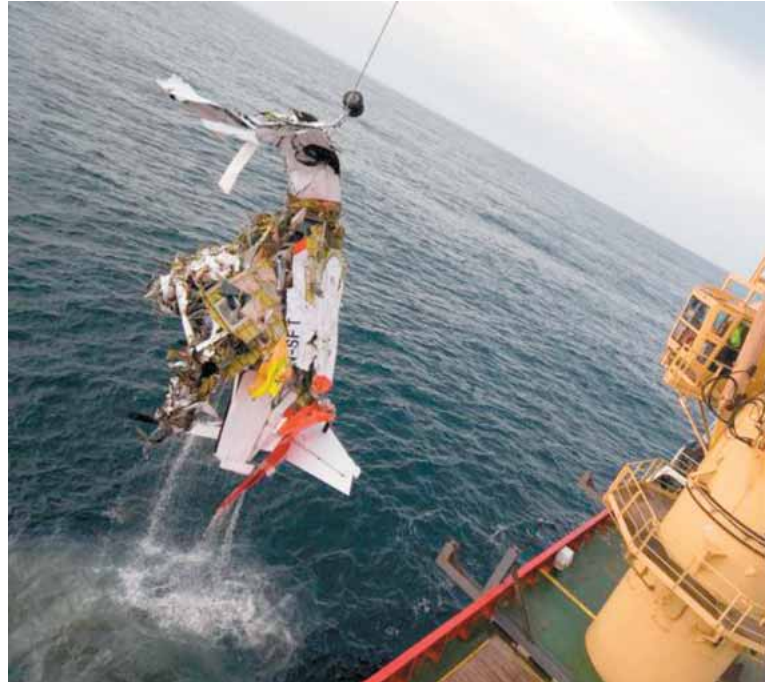
PRINCE's HiPAP system, an integrated part of its Dynamic Positioning System, capable of operating in the 37,5 kHz range. An ROV then found the wreckage at a depth of 316 metres. 90% of the wreckage had been lifted onto the ship's deck within two hours of the detection of the ULB signal (pictured opposite). The total cost of the operation was 155,000 euros.

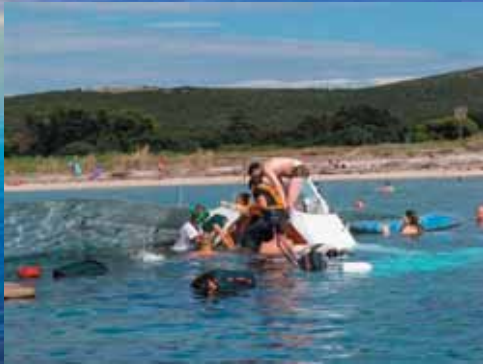
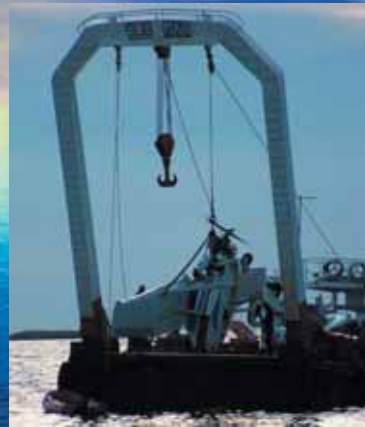
Specially equipped
salvage ship
brought the
aircraft from
depth of 15 m

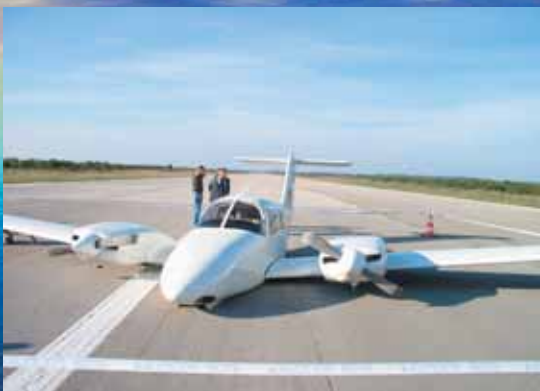
PA-44 belly landing at Zadar

Cause of the PA-44 accident:
micro switch failure

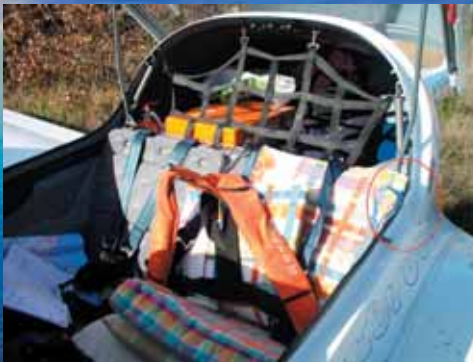
DA-20 canopy unlocks and open mid-flight:
seat cushion jammed in canopy frame

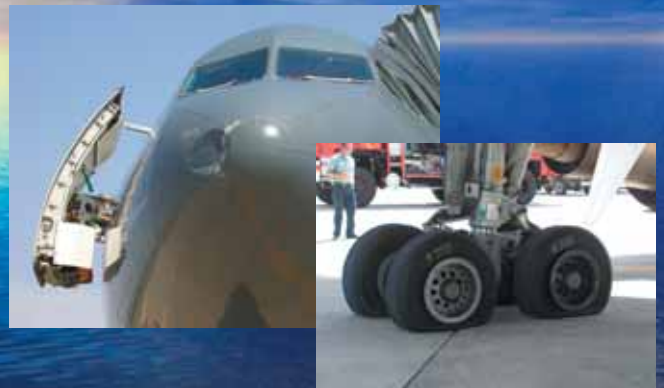
Airbus 310 bird strike at LDZA during take off run
- only one tire left after immediate braking

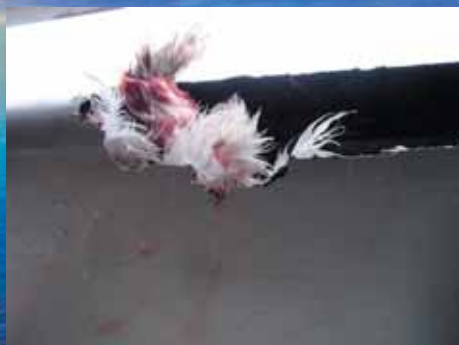
Another bird strike on LDZA Zadar
Airbus 319

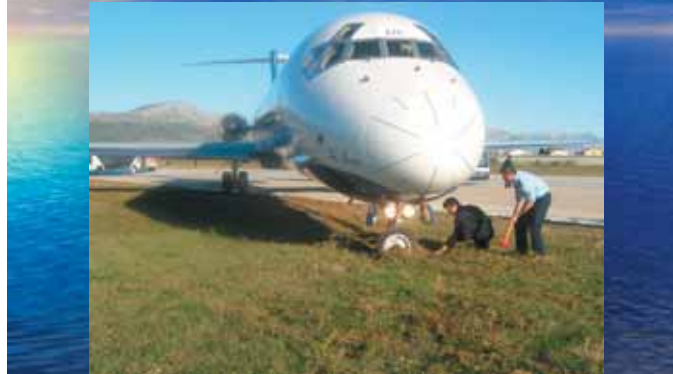
Airport Split incident of MD-80
- too strong steering on RWY, bad pilot decision

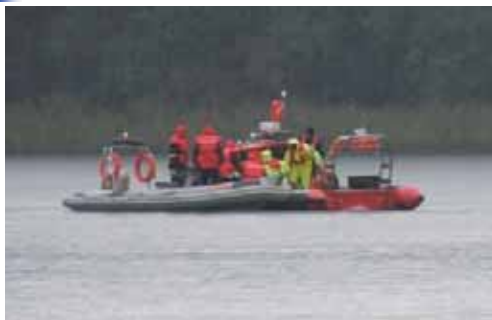
Fire brigade boat with sonar
2 days searching, very limited area thanks
eyewetness statement

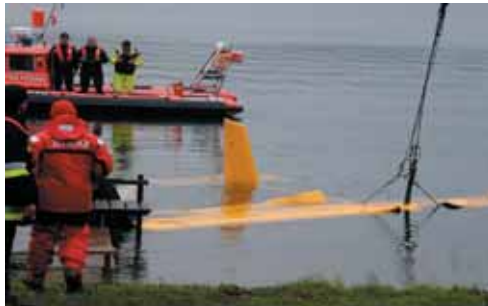
Wreckage located on floor 8 m deep. After using rubber pontoons to recover the aircraft was towing to the bank.

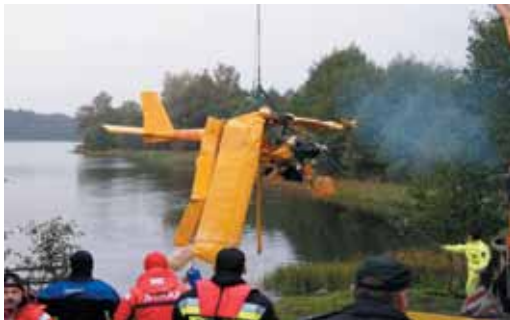
Operation lasting 12 hours
2 teams of 2 divers

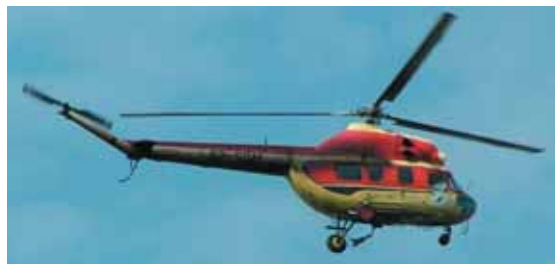
Accident 2 - July 2005

Helicopter Mi-2 during fire operation was taking water to bucket and took the water with mud and overloaded. Stalled and crash to the lake. Pilot survived.

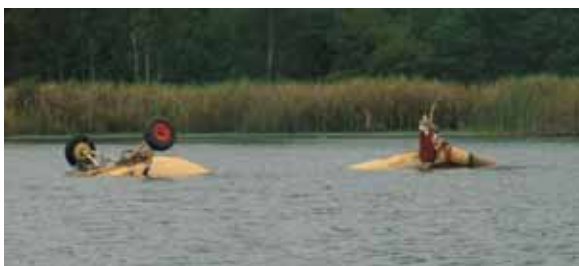
Located in shallow lake

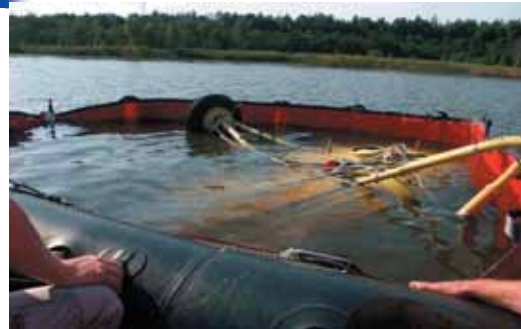
Ecological problem - about 400 l of fuel.
During pumping out the fuel wreckage was surrounded by special protection (curtains)

After pumping out of the fuel wreckage was towing to the bank

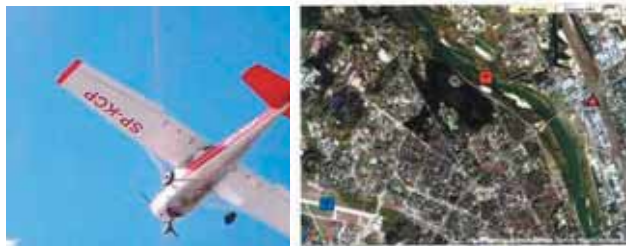
Accident 3 - training flight Cessna 150 M in area Warszawa-Babice (EPBC)

Carburetor icing – loss power.
No place for force landing due to urban Warsaw area.

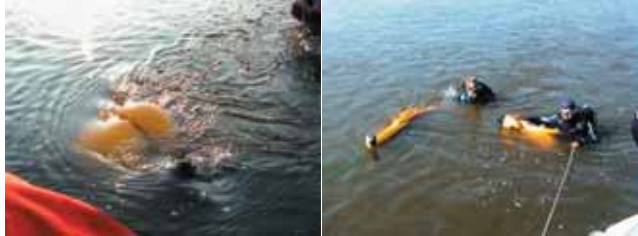
First attempt to recover by using rubber pontoons (banana shape) under wings and engine failed due to puncture the pontoons by sharp edges of aircraft

The first attempt to recover the aircraft, using ropes deployed from the bank by the fire service, did not succeed. A second attempt, again using ropes but deployed from a barge, also failed. There followed a reconnaissance of the wreckage by divers, who had been briefed on the aircraft type, and an attempt to recover it using inflatable rubber pontoons positioned under the wings and engine. This, too, proved unsuccessful, when the sharp metallic edges of the wreckage punctured the pontoons.

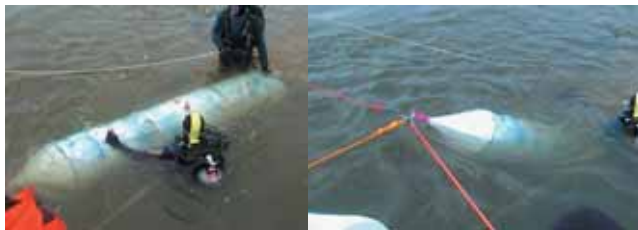
Second successful attempt by using metal containers – 7-8.11.2007 r.

- Preparing action
- sand washing, sucking of the sand;
 - time - 20 hours, 4 boats

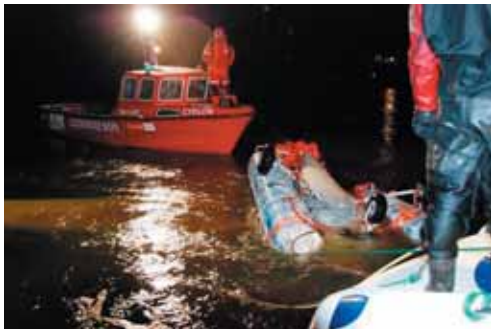
Very slow towing in overturn position

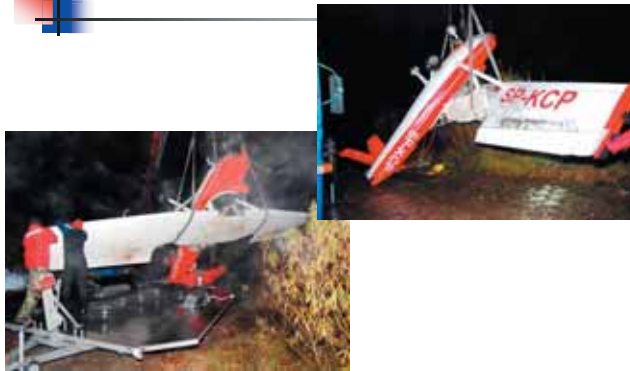
Crunching the aircraft

- aircraft in overturn position;
- Vistula wild river – no barge with crunch;
- high stream;
- sand mine;
- problem with binding containers;
- Two big boats with 3 anchors each;
- two divers working;
- first attempt – no movement;
- any longer brake - more mud and sand;
- very bad weather: rain, snow, temp. 2-5°C, water temp. 6-7°C.

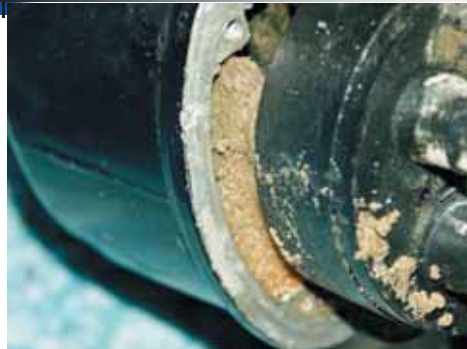
Aircraft – sand everywhere magneto

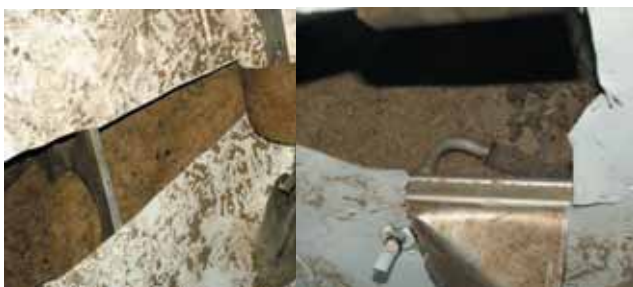
Aircraft – sand everywhere wings

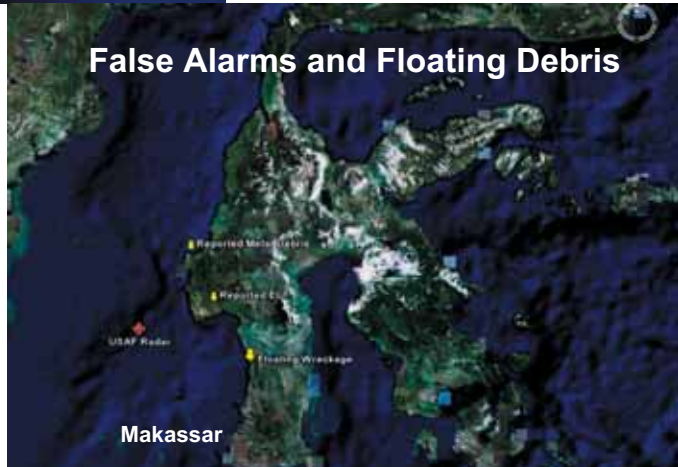
Mobilization for Underwater Search

- Phoenix Intl (via USN contract)
- 6/13-14: crew + two TPLs, SS sonar, and two winches (7K & 23K cable) depart military & commercial
- 6/18: equipment installed on USNS Mary Sears
- 6/19: Tested/repared equip.
- 6/20-21: TPL runs
- 6/24: SS runs
- 6/25-27: return and demob.

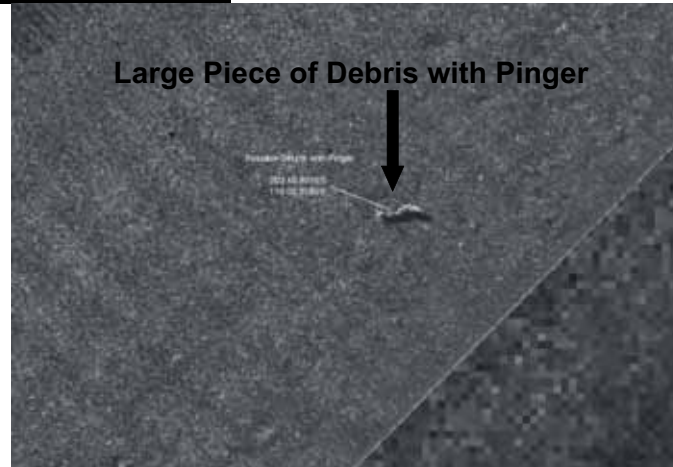
Recovery Operation

- 8/24-25: 15-hr transit from port to site
- Early equipment & Dyn Pos problems
- 8/25-26: ROV dove on both pinger GPS locations
 - no debris seen
- 8/27-28: FDR then CVR found between GPS loc's (2/3 days after search began)
- Remaining days spent mapping debris
